Manhole Inspection Summary

Manhole # S29M__026MH

Location Address: **Scott St**

Cross Street: **Carroll St**

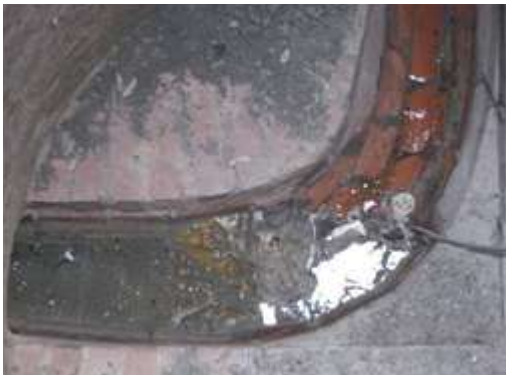
Misc

debris in channel

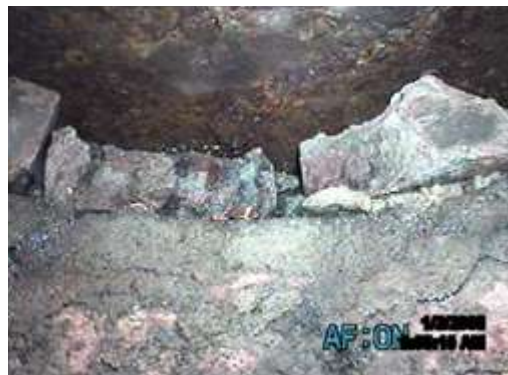
Defect 1

Condition: ☐ Sound ☐ Cracked ☐ Root Intrusion ☒ **Deteriorated** ☐ Leaks ☐ Debris

debris in bench as well as deteriorated

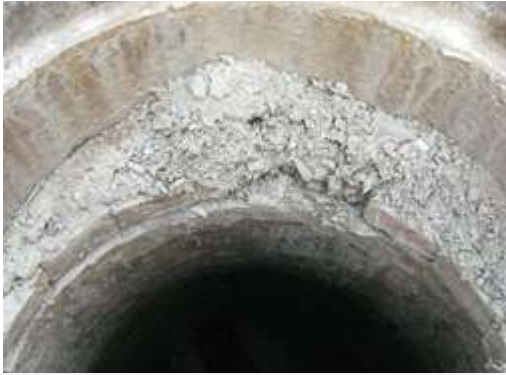
Defect

Frame Offset: **3.5** (in.) Condition: ☐ Sound ☐ Cracked ☒ **Leaks**

frame leaks

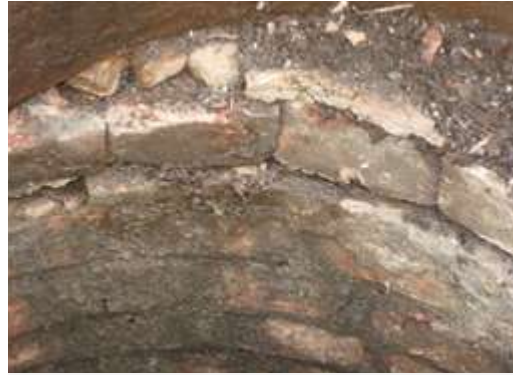
Defect

Condition: ☐ Sound ☐ Cracked ☐ Root Intrusion ☒ **Loose Brick** ☒ **Deteriorated**

Infiltration: ☐ None ☒ **Joint** ☐ Cracks ☐ Mortar ☐ Roots ☐ Wall

broken bricks, infiltration joint of chimney and frame.

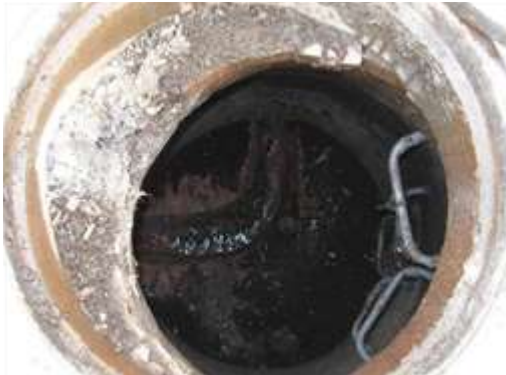
Defect

Offset

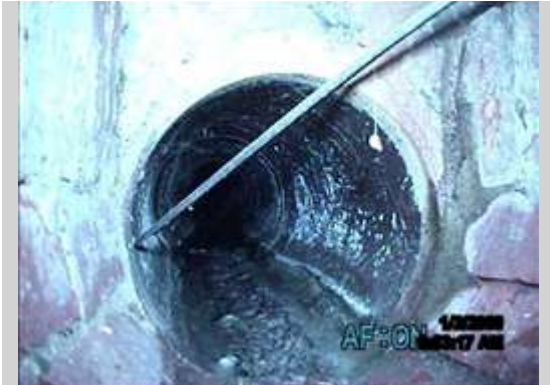
12 O'Clock Outflow

Pipe Height: **8.4** (in.) Rod and Bar (Angled)
Pipe Material: **Clay** ☐ Pipe Lined
Invert Depth: **9.20** (ft.) Flow Characteristics: **Slow**
Deposits: ☒ None ☐ Mud ☐ Sludge ☐ Debris ☐ Grease
Silt Depth: **0** (in.) Deposits Extent:
Infiltration: **None** Pipe Seal Cond: **Sound**
